PHASE I ENVIRONMENTAL SITE ASSESSMENT REPORT

**1301 HADDON AVENUE
BLOCK 1322, LOT 55
CAMDEN CITY
CAMDEN COUNTY, NEW JERSEY**

Conifer Realty, LLC
20000 Horizon Way, Suite 180
Mount Laurel, NJ 08054

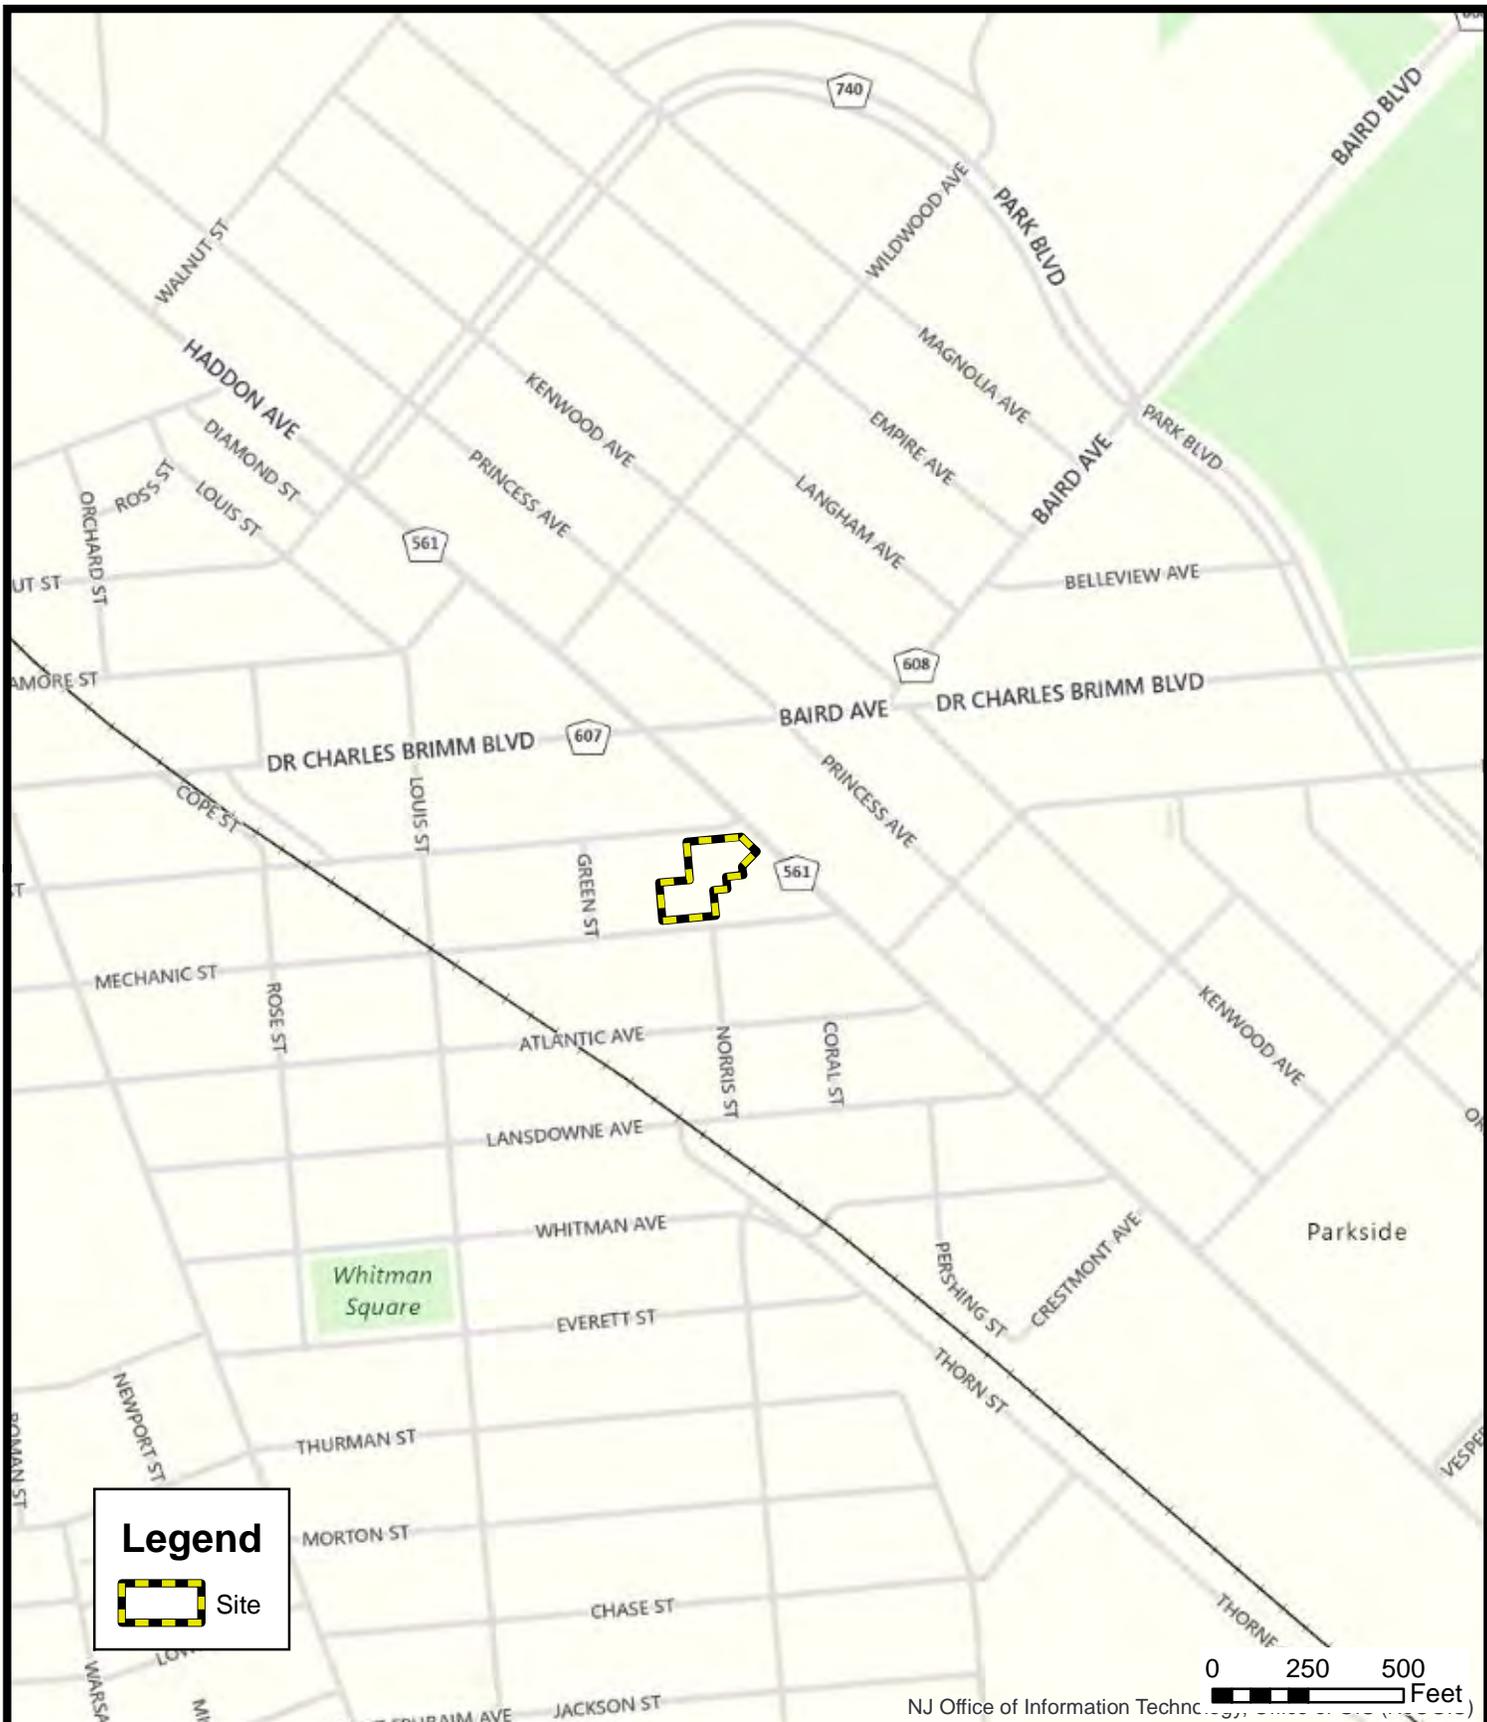
FIGURE 2: NEW JERSEY GIS BASE MAP

The site property consists of Block 1322, Lot 55 in the City of Camden, Camden County, New Jersey and comprises approximately 0.72 acres. The Site is located south of Liberty Street, north of Mechanic Street, and southwest of Haddon Avenue. This location is depicted on **Figure 1: USGS Location Map**, **Figure 2: New Jersey GIS Base Map**, and **Figure 3: 2020 Aerial Photograph**.

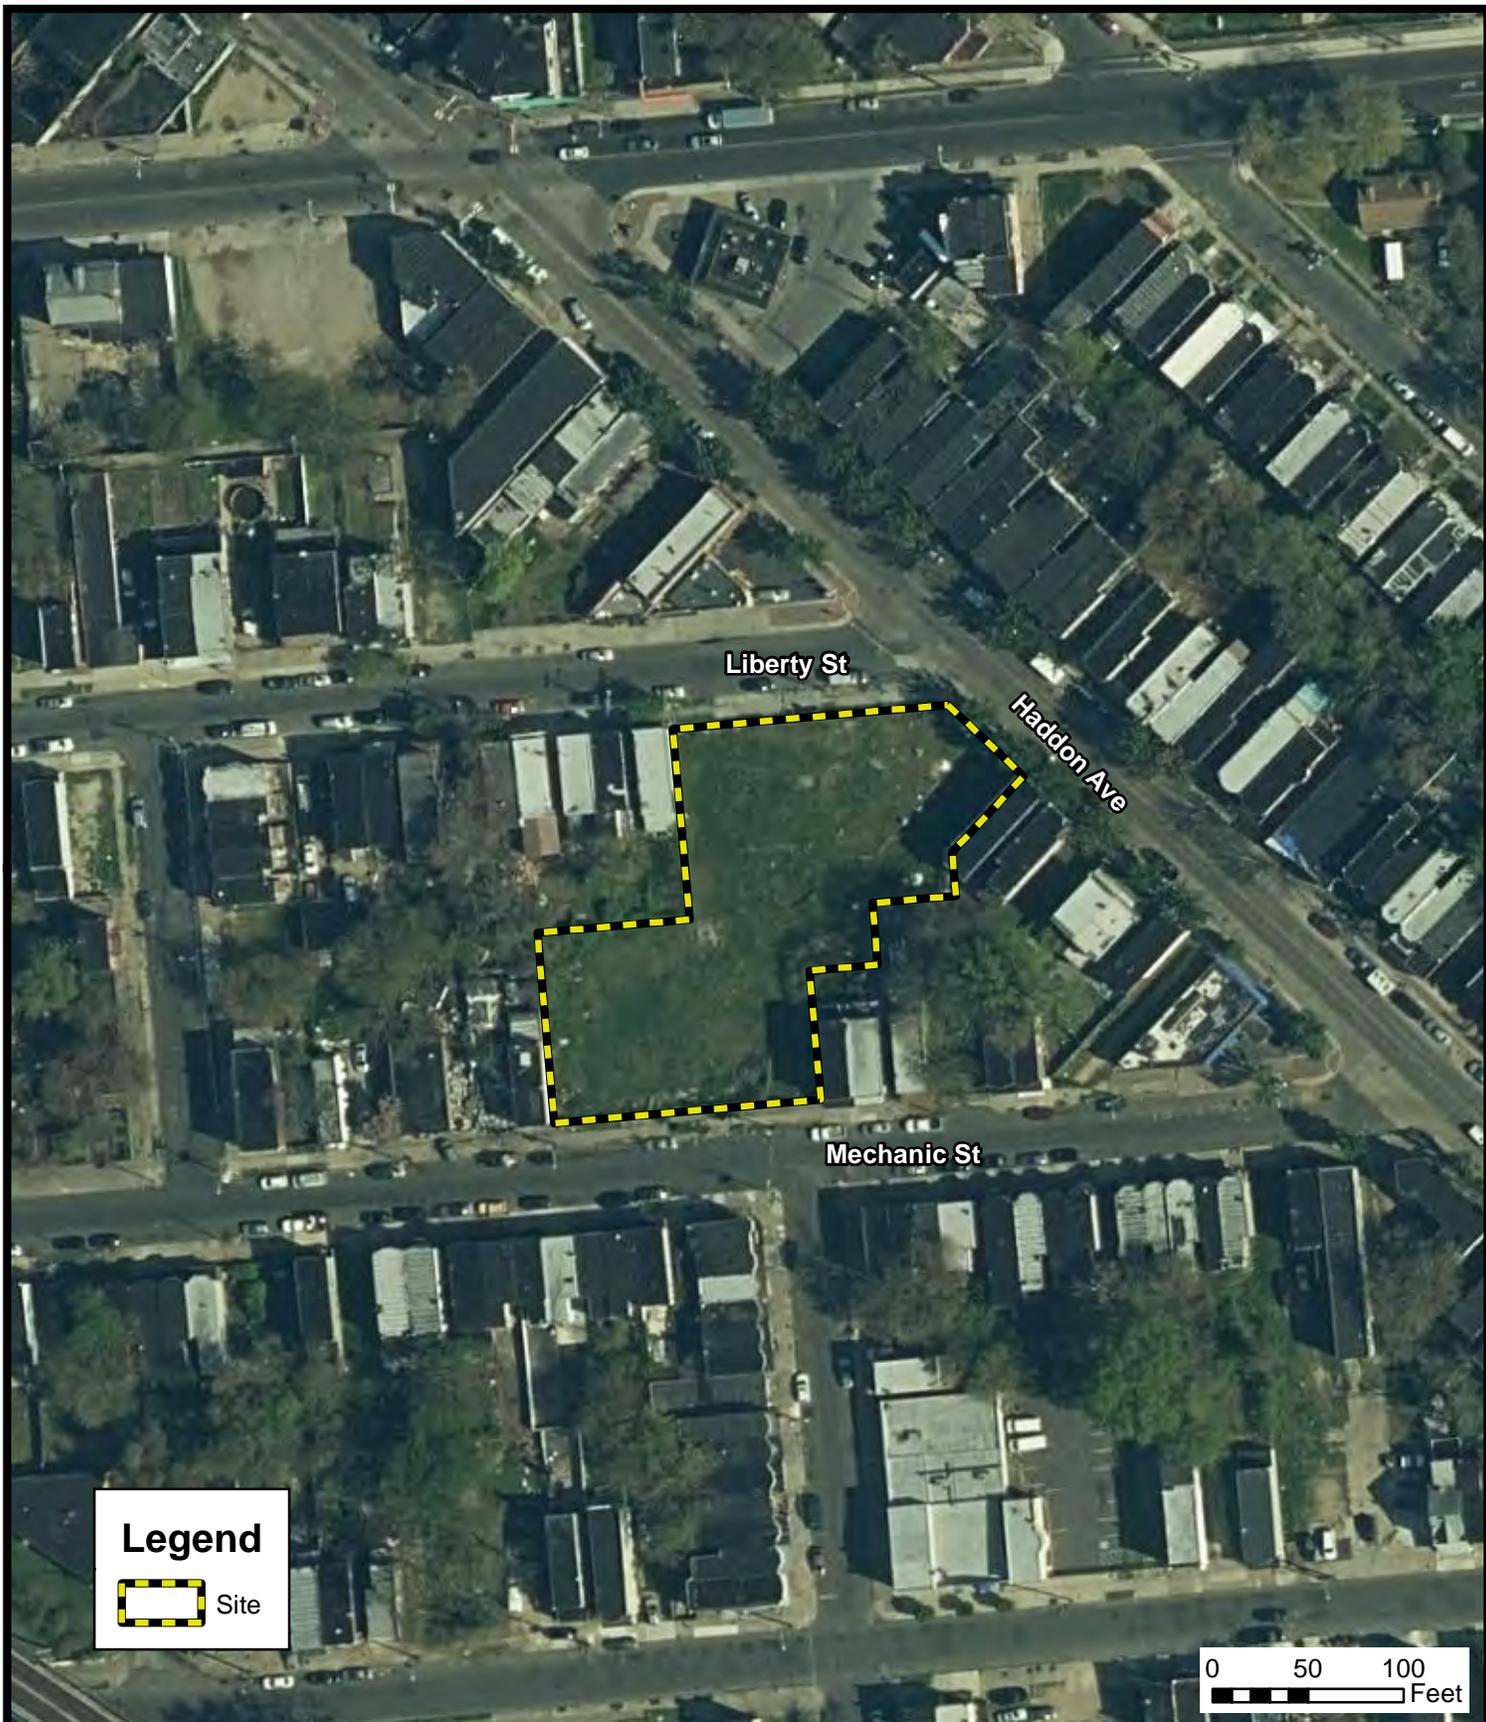
FIGURE 3: 2020 AERIAL PHOTOGRAPH

The Site is vacant except for several building foundations.

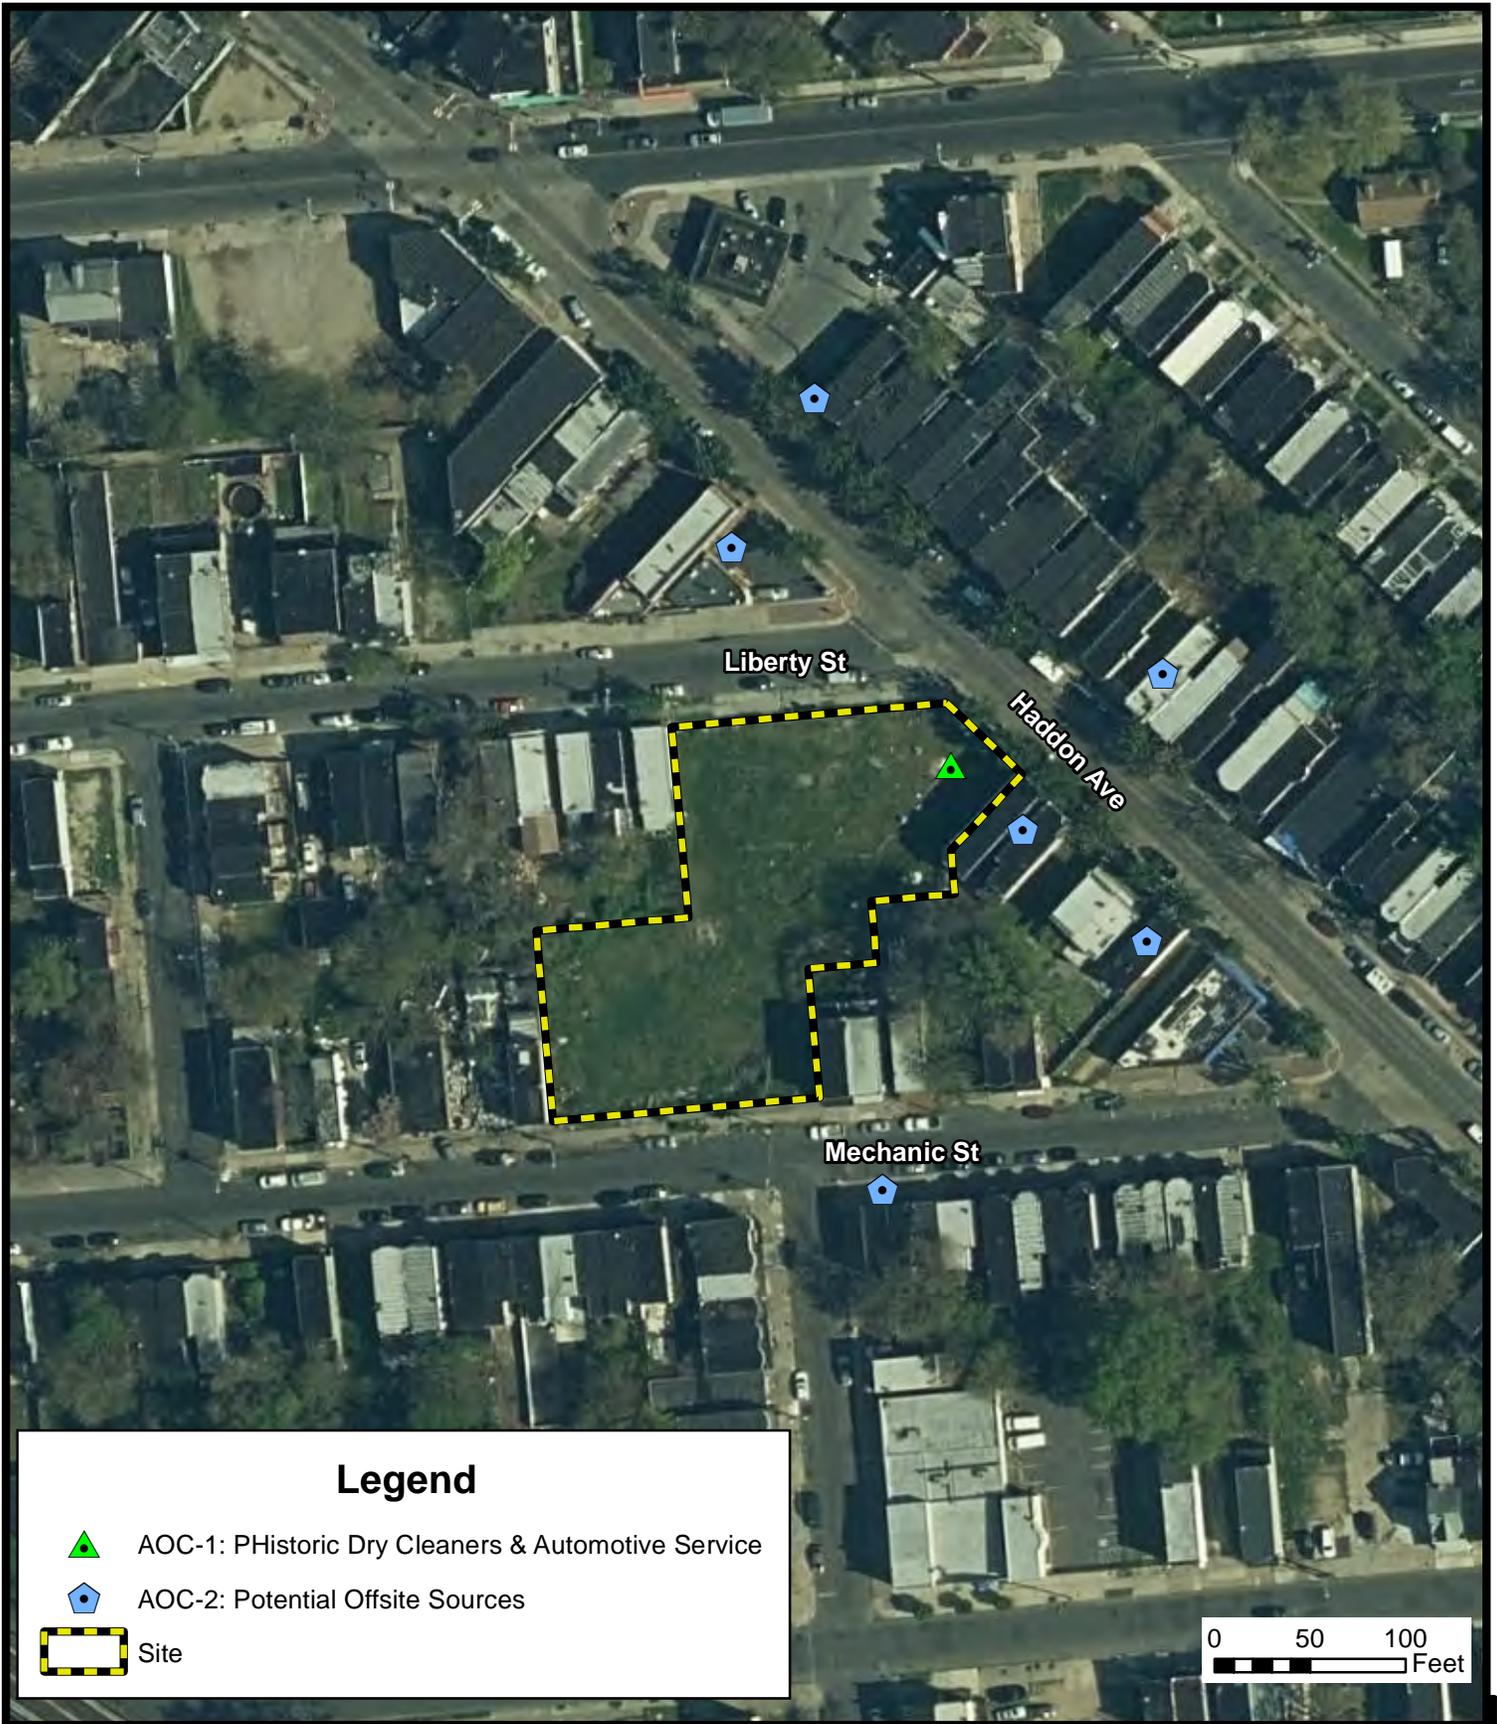
- AOC-A: Historic Dry Cleaners and Automotive Service
- AOC-B: Potential Offsite Sources

AOC locations are depicted on **Figure 4: AOC Map**. Recommendations for the AOCs are provided below.

This AOC is also considered to be a REC. It is recommended that a Site Investigation be completed for this AOC/REC that includes the collection of soil and groundwater samples for laboratory analysis.

This AOC is also considered to be a REC and a Vapor Encroachment Condition (VEC). It is recommended that a Site Investigation be completed for this AOC/REC/VEC that includes the collection of soil, soil-gas, and groundwater samples for laboratory analysis.
